DISCOVERING, THE HARD WAY, HOW A HIGH PERFORMANCE COUPLING INFLUENCED THE CRITICAL SPEEDS AND BEARING LOADING OF AN OVERHUNG RADIAL COMPRESSOR—A CASE HISTORY

ABSTRACT

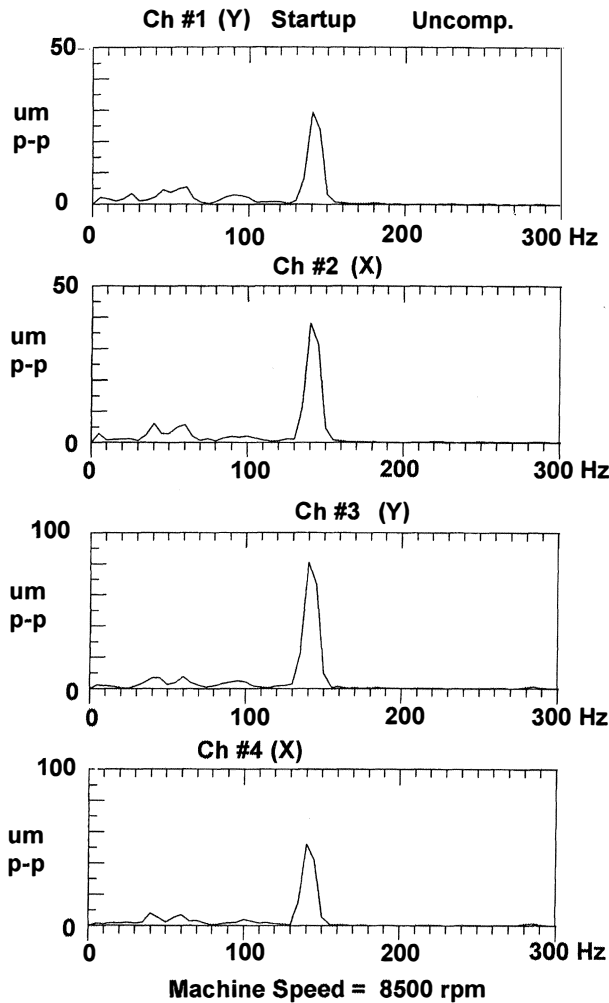
Figure 7. Original "Unbalance" Spectrum.

this 8500 rpm limit. The $1\times$ filtered vs direct amplitude was comparable with little or no phase shift. FFT analysis indicated a clear $1\times$ response that was initially interpreted as simply an unbalance condition. A typical set of system responses for these initial observations is shown in Figures 7, 8, and 9.

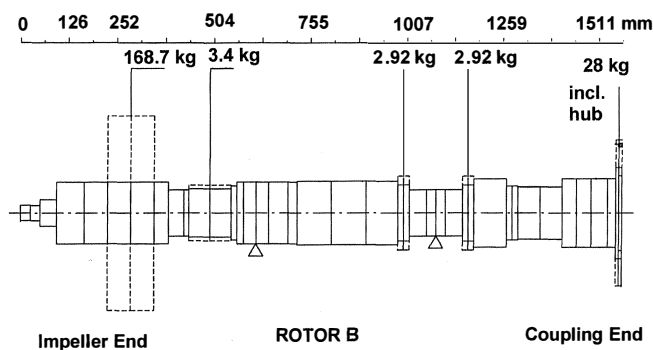
Figure 12. Rotor Model B—With Actual Contract Coupling Weight.

The contract coupling as delivered, however, was a standard design weighing 28 kg at the shaft end. The actual weight was somehow missed in the communication between the compressor and turbine manufacturer, as mentioned previously. The rotor model (rotor B) and forced damped unbalance (using the same unbalance of 1.06 kg-mm at the coupling end) response model and mode shape is shown in Figures 12 and 13, respectively. Calculated critical speeds and the amplification factor are shown in Table 1, column B. The first critical speed was at 3800 rpm and the second was at 9100 rpm, very near the problem speed on the test stand!

But, even though the observed test resonance was very likely related to the new rotor (rotor B) model second critical, the rotor had been calculated to be critically damped, with an amplification factor of 1.2 (Table 1). Damped Eigen value stability analysis showed no problems. Log decrement values were well in the stable range. The high amplification was completely unexpected and more investigation was necessary.

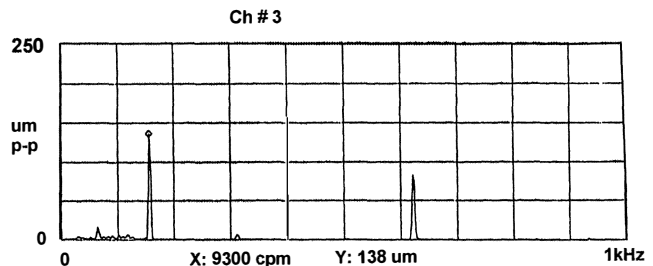
Figure 14. "Resonance" Spectrum.

through the resonance. The observed vibration magnitude was up to 250 μm with a corresponding phase shift. This result appeared to be only the initial onset of the resonance. The machine could be run up to 9300 rpm, with stable amplitudes at 40 μm to 60 μm with no phase shifting. But once the speed was increased above 9400 rpm, the amplitude would increase dramatically. Depicted in Figures 14, 15, and 16, are the nature and magnitude of the vibration.

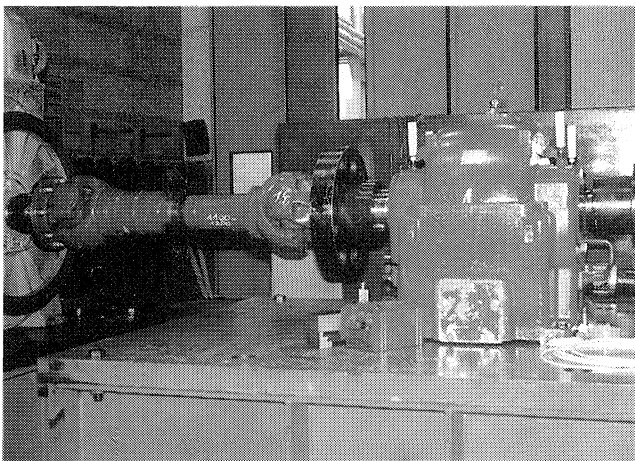
Figure 17. Original Gearbox and Cardan Shaft.

- *Cardan shaft*—The Cardan shaft (Figure 17) was also theorized as providing a source of the vibration. Following checks of the original unit balance records that showed an acceptable residual unbalance, another unit of approximately double the mass and physical size was substituted, with no significant influence. Therefore, this component was eliminated from the discussion.

- *Test gearbox*—The test gearbox was suspected as inducing the vibration. The original unit, also depicted in Figure 17, was a double helical unit of 1:3.11 ratio used to increase the available output speed of the DC motor. The gearbox generated some relatively high vibration readings. However, attempts to isolate this source of the resonance were inconclusive following disassembly and inspection of gearing and bearings, mechanical runout measurements and rebalancing of both input and output shafts, and gearing. Analytical methods incorporating the characteristics of the output pinion into the lateral/torsional model also showed no significant influence. A high level subsynchronous vibration ($0.45\times$ to $0.49\times$) was eventually isolated within the output shaft

bearing system. This gearbox was replaced with a larger capacity unit of 1:5 ratio that would allow operation at the full operating speed of 10,500 rpm and is shown in Figure 18. There was no measurable change to the vibration characteristics. Measurements of radial and axial vibrations, thermal growth, and mechanical runouts on input shafts, output shafts, bearing systems, and casing provided no relevant information. Due to the lack of system response following the gearbox replacement, this component was eliminated from the investigation.

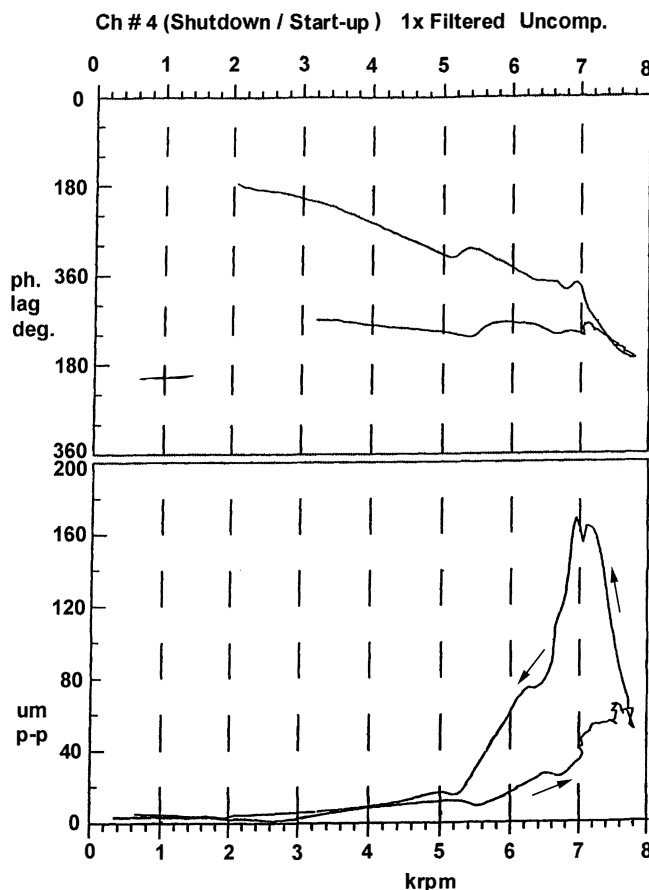
Figure 21. Bode Plot of Original Test Coupling with First Trial Weight.

It should also be noted here that there appears to be jump phenomena depicted on Figure 21, which indicates a highly nonlinear condition. However, it was assumed at the time, possibly incorrectly, that the odd vibration behavior was related to the unbalance in the weight ring assembly.

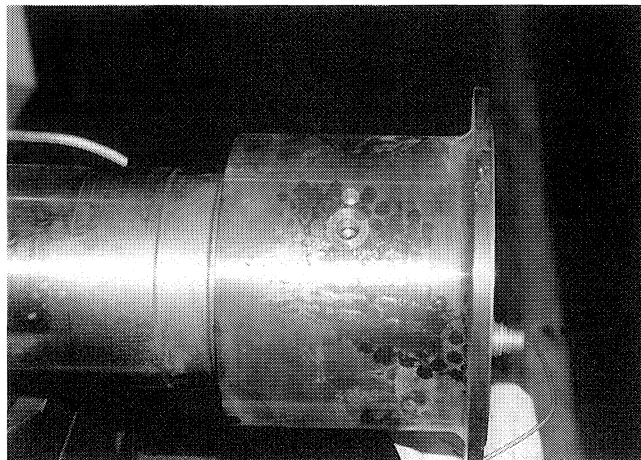
Figure 27. Unbalance in Original Contract Rigid Hub.

The contract coupling, which had been returned to the factory for inspection, had significant unbalance (230 g-mm) in the rigid hub; unbalance that was not reflected on the original balance report. Apparently, permanent field corrections (drilled holes in the hub body) had been made to the rigid, to account for the unbalance introduced in the hub when a threaded plug was inserted into a hydraulic port hole for dust/contaminant protection (Figure 27).

Rotor response to unbalance calculations were done to see if this rigid hub unbalance could have caused the severe vibration levels. The results were marginal; the unbalance in the rigid could have contributed to the problem, but it was probably not the only cause.

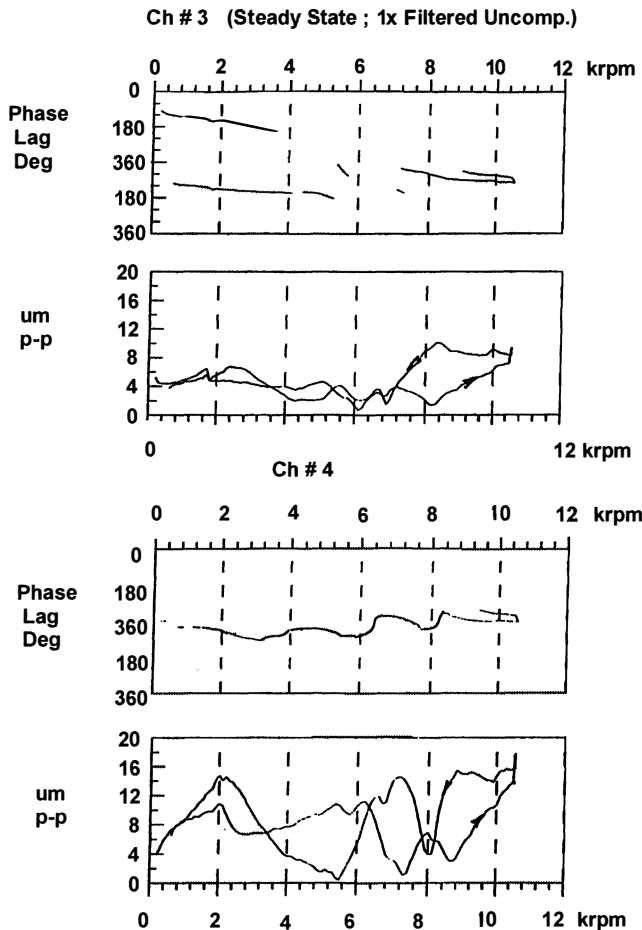
Figure 29. Final Successful Run Bodé Plot.

After the mechanical test run with the heavy coupling arrangement (rotor E), it was reported “... the maximum direct (vibration amplitude) values (were) $< 25 \mu\text{m}$. Therefore, the sun is shining today!!!” The final run values are shown in Figure 29. The compressor was shipped shortly thereafter for mechanical linkup with the gas turbine.
